Upstream Raise Tailings Dams from a Low Risk Appetite Perspective: A Case Study

R. van der Westhuizen¹, G. Coetzer²

Abstract

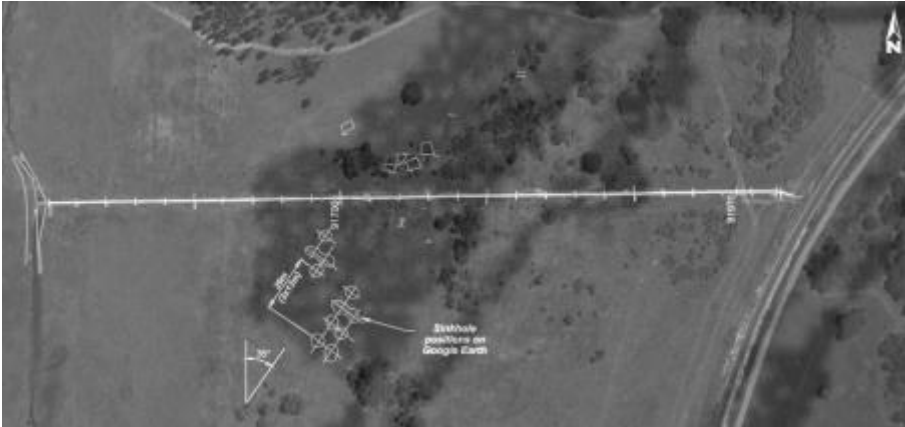
Figure 1. Undermining plan overlain on Google Earth image.

The natural topography of the site slopes in a westerly direction towards a stream. Based on the location of the mine adits located on either side of the stream, it was believed that the coal seam is probably fairly horizontal. Thus the thinnest overburden would be situated along the western edge of the undermined area. Most of the sinkholes visible on surface formed near the western edge of the undermined area.

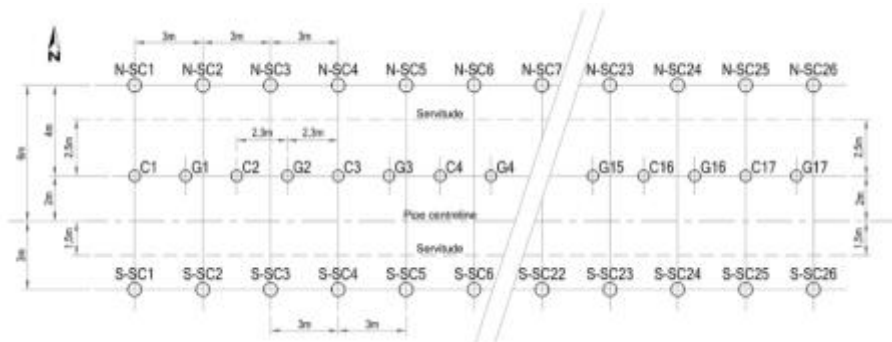
Figure 2. Typical layout for stone cone, concrete and grout boreholes.

The borehole layout and sections showing the primary and secondary stone cones with the concrete placed between the stone cones are shown in Figure 2 and Figure 3.

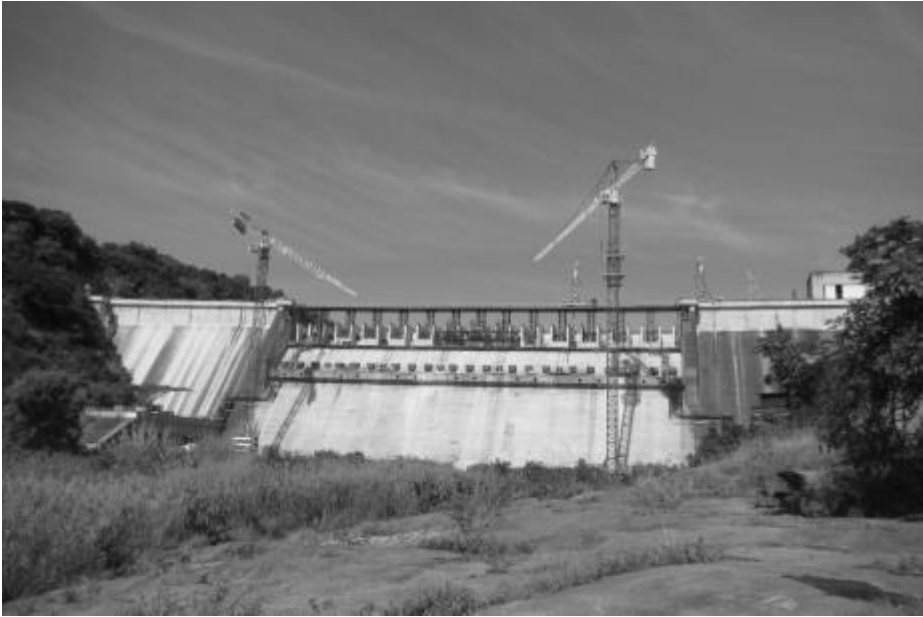
Figure 1. View of the Hazelmere Dam during raising

The reinstatement of the grout curtain commenced in October 2015 and was completed in October 2016. The dam was operational during construction even though a reduced water level was maintained. Figure 1 depicts the dam wall as seen from downstream during the raising of the dam wall. The longitudinal section through the dam wall with the length and spacing of grout curtain holes drilled from the drainage gallery is provided in Figure 2. A typical cross-

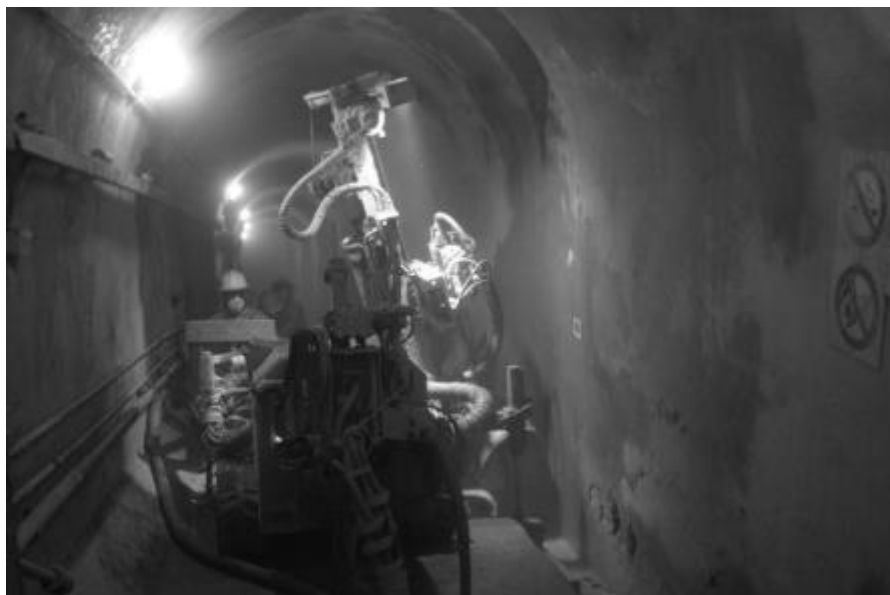
Figure 4. Drilling operation inside the drainage gallery

The grout curtain reinstatement was mainly carried out from the confined conditions of the drainage gallery. This necessitated the use of small drill rigs with limited rod length. Drilling and grouting were done from the dam crest on the upper parts of the right flank as access for the drill rig inside the drainage gallery from the steep staircase was problematic. A drilling operation from the spillway section of the drainage gallery is illustrated in Figure 4.

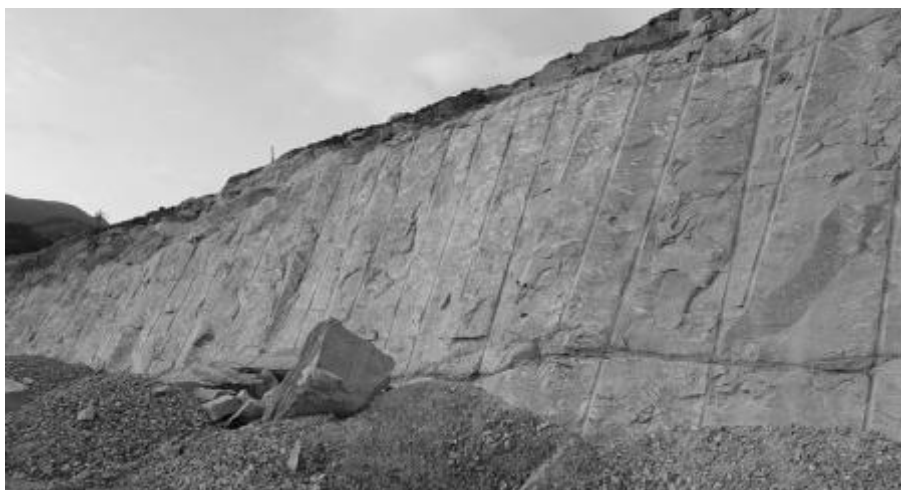
Figure 2. Very hard rock with little jointing at the box-cut where soil nail spacing was increased

The only design adaptation to date was an increased soil nail spacing in the localised area indicated in Figure 2 as better quality material was encountered than that assumed for the original design. This was possible due to good site supervision and construction monitoring practices.

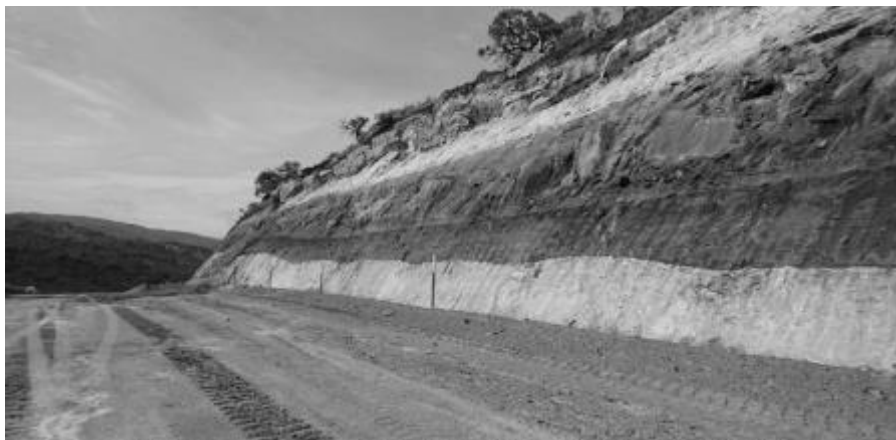
Figure 3. Cutting on access road excavated to some 10m deep

Several cuttings on the access road were fully excavated (up to 10m deep) prior to installing lateral support measures as indicated in Figure 3. This might have been done in an attempt to accelerate the programme, in which case it wrongly took precedence over the stability of the cutting.

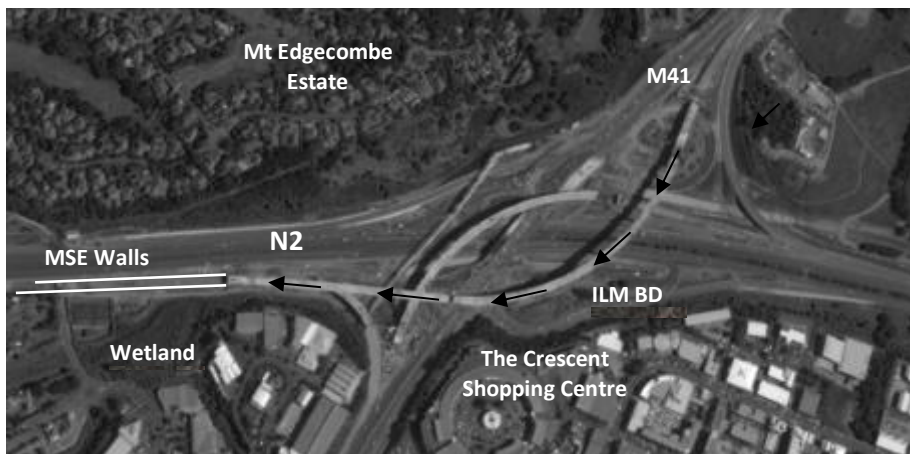
Figure 1. Mount Edgecombe Interchange configuration

originally built, i.e. the M41 and N2 are not perpendicular to one another. This skew angle of the interchange is shown in Figure 1. The close proximity of existing developed areas, such as Mt Edgecombe Estate and The Crescent Shopping Centre, further restricted space adjacent to the viaducts. As a result of the horizontal space constraints, as well as the existence of a protected wetland area adjacent to ILM BD's exit, the implementation of back to back Mechanically Stabilised Earth Walls (MSEWs), as opposed to conventional sloped embankments, was selected to tie the viaduct into the existing N2 freeway.

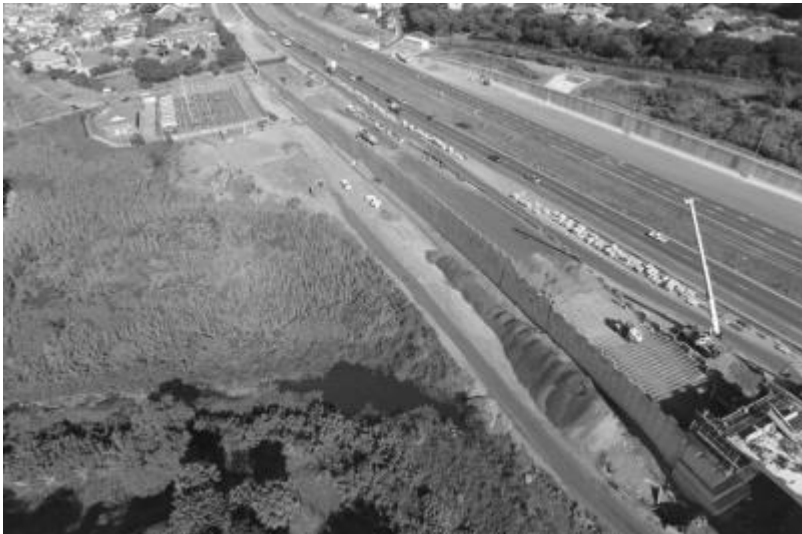
Figure 2. Aerial photograph of MSE Walls 6 and 7

Both bearing capacity and circular slip failure checks indicated that additional ground improvement measures were required below the foundation of MSE Wall 6. An additional concern was the potential differential settlement expected at the abutment interface of MSEWs 6 and 7 and the deck of ILM BD. As a result, foundation improvement was specified under the high fills of the two MSE walls. Foundation or soil improvement consisted of Replacement Stone Columns installed with the Dynamic Compaction (DC) method in combination with a G6 raft and high strength bi-directional geotextile for areas where the wall height of MSEW 6 exceeded 7m. Where the wall height varied between 4m and 7m, only a G6 raft was specified and no foundation improvement was specified at wall heights of less than 4m to limit differential settlements between the height ranges as per SANS207:2006. The external stability checks and finite element analyses were reviewed by a peer review process.

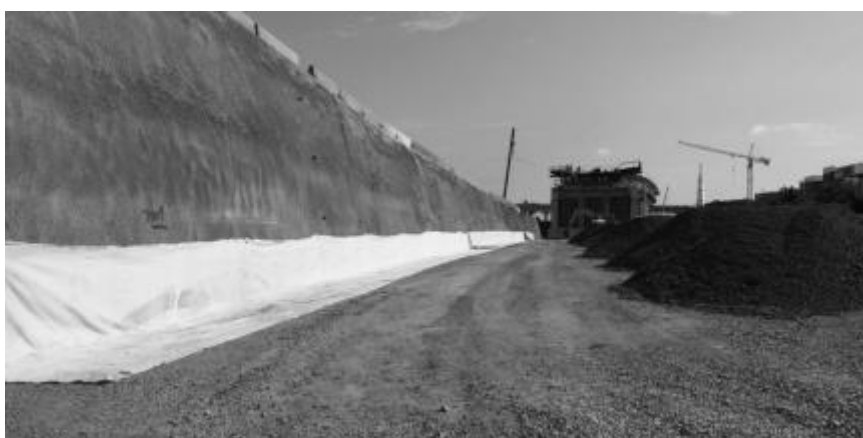
Figure 4. A typical cross section of MSE Walls 6 and 7 as well as the temporary soil nail wall

The above interface was considered in finite element analyses and shown to be marginally satisfactory (FOS around 1.5). However, as an additional precautionary measure, methods as described in Wu and Helwany (1990) were implemented to alleviate potential bridge approach settlements. The solution which was implemented is displayed in Figure 4. The solution agreed upon entailed placing a 2.5m width of Rockgrid, a bi-directional polyester geosynthetic, along the length of the shotcrete, with 1m placed vertically and the remaining 1.5m laid horizontally on top of the layer. The geosynthetic material was held in place by dowelling lengths of Y10 rebar through the top of the geosynthetic and into the face of the shotcrete wall. The next fill layer was then placed and worked up to the rough shotcrete wall face, thereby ensuring a degree of interlock. These “strips” of geosynthetic material were placed continuously up the wall at 2m height intervals

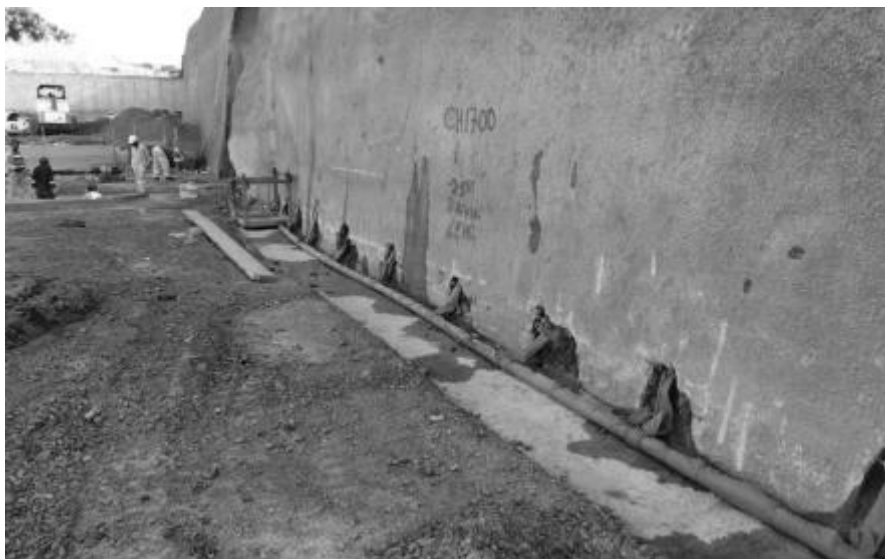
Figure 5. Drainage of layerworks and temporary soil nail wall band drains

During the construction of the fill layerworks, wet spots were noted along the face of the shotcrete wall. This was attributed to the downward slope of 2-4% of the layerworks, to ensure runoff away from the MSEW panels; the wet spots were further attributed to seepage from the band drains which had been installed behind the face of the temporary soil nail wall. The solution, as photographed in Figure 5, consisted of a rudimentary subsoil drain, similar to those use behind the abutments to structures. A subsoil drain pipe, wrapped in bidim, was placed on a small concrete foundation along the length of the entire soil nail wall at a longitudinal slope of between 0.5 and 1%. This pipe then drained into a stormwater pipe inlet at the northern end of the wall which in turn drained into the attenuation dam/wetland area. Additionally, the positions of the band drains behind the shotcrete face were located, exposed and wrapped into the subsoil drain pipe to allow for sufficient drainage of hydrostatic build up behind the soil nail wall.

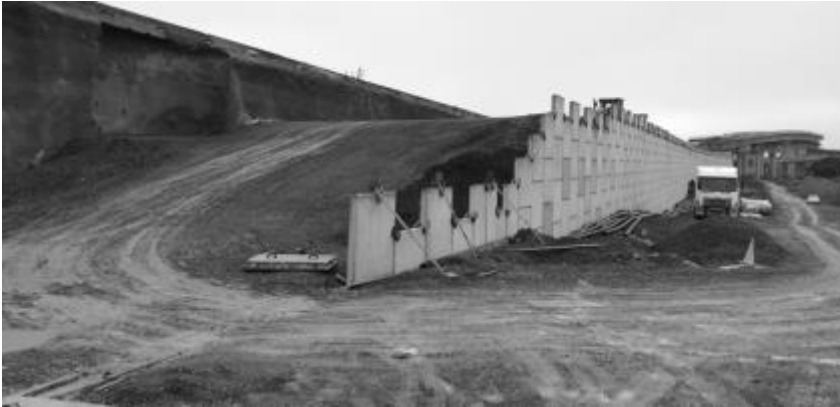
Figure 7. Bottom access ramp between MSE Wall 6 and Mount Edgecombe Drive Underpass

The Contractor undertook to build the wall from the abutment southwards, stopping 35m short of the underpass to allow for access via the last platform. He continued to build MSE Wall 6 up to this point, until the ramp to the top of the fill behind the wall became too steep. At this point, back to back construction of the ramp had commenced at the northern end of MSE Walls 6 and 7. Once the walls were at the required level (deemed to be approximately 1m below top of road level on the adjacent freeway), a ramp was constructed over the top of MSE Wall 7, to allow for plant and material access from the top. A photograph of the bottom access ramp is shown in Figure 7.

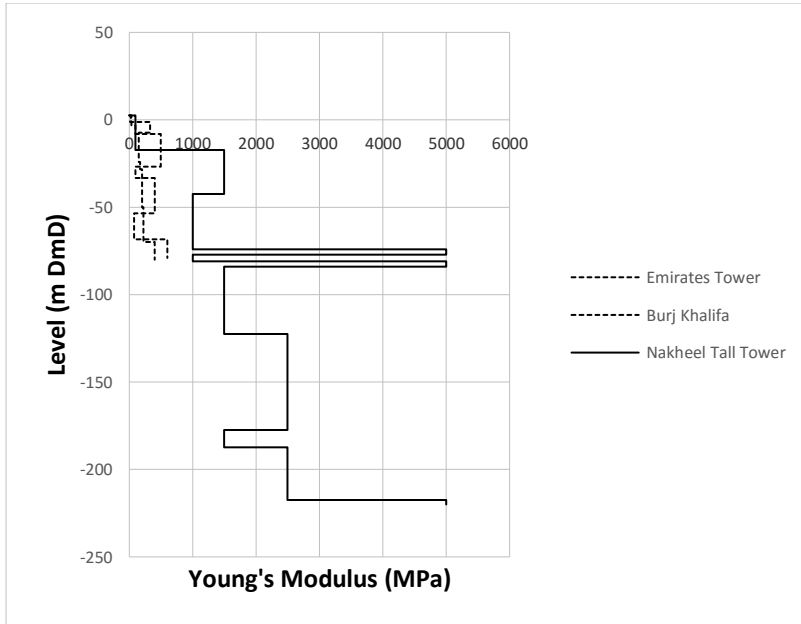
Figure 1. Design modulus with depth.

For the three considered Towers, Young's modulus values were derived based on a combination of data from a variety of insitu and laboratory tests including pressuremeter testing, resonant column tests, unconfined compressive strength tests, laboratory stress path tests, standard penetration tests (SPT) and p-s suspension testing. The modulus design values applied for the foundation design for the Burj Khalifa, NTT and ETT are summarized in Figure 1. For the ETT and Burj Khalifa failure of the test barrettes could not be achieved and the designers chose to cap assumptions within the known limits from the test pile data. Thus the parameters adopted are more conservative than those applied for the NTT. Poulos and Bunce (2008) reported that the movement estimates and monitored operational data for the Burj Khalifa were significantly lower than ground movements predicted during the design and were therefore quite conservative. For NTT, the designers took a different approach to parameter selection and were able to mobilise more shaft resistance in the test piles influencing their more favourable selection of design parameters. The approach adopted for the NTT design shifted the current view and pushed the boundary on the way parameters are selected.

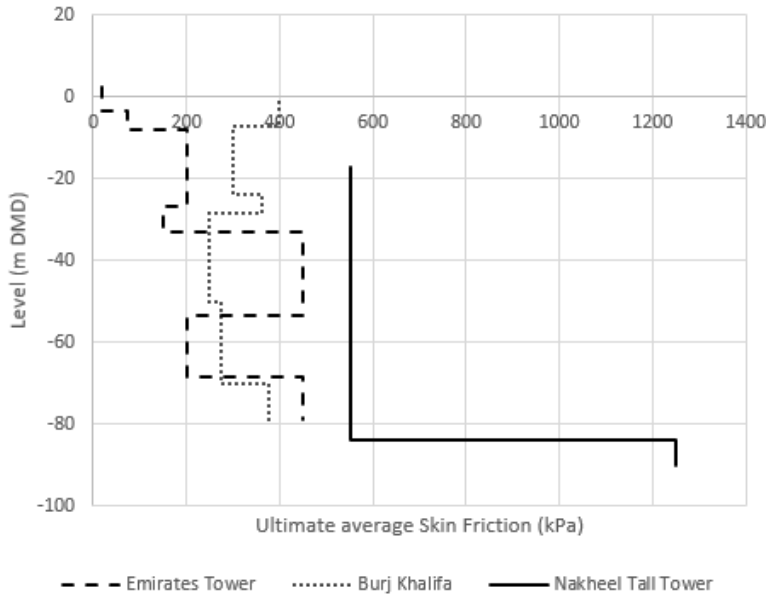
Figure 2. Skin Friction with depth.

The skin friction values applied for the pile foundation design for ETT, Burj Khalifa and NTT are summarized in Figure 2 and based on full-scale testing results. The skin friction design values assumed for the Burj Khalifa and ETT vary quite significantly from those applied for the NTT. For both the ETT and Burj Khalifa projects, no conclusions could be reached on end-bearing as none of the test piles appeared to have overcome frictional capacities of the piles and failure of the test piles could not be achieved. The designers chose to cap design assumptions within the known limits based on full scale testing results. The design values applied for the NTT project may be more realistic values with approximately 550kPa to 600kPa in the calcisiltite unit with increased values of 1250kPa below -80m DMD. For tension shaft capacity, the Burj Khalifa design utilised a tension shaft capacity of 50% of compression shaft capacity. This correlates well with a theoretical relationship between tensile and compressive skin friction developed by De Nicola and Randolph (1993) which indicates a factor of 0.6.

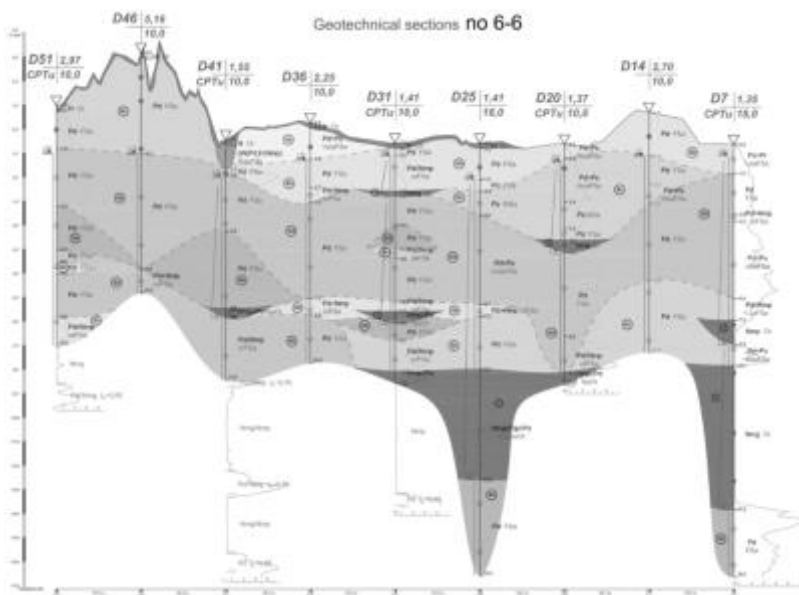
Figure 2. Typical geotechnical profile in the platform area.

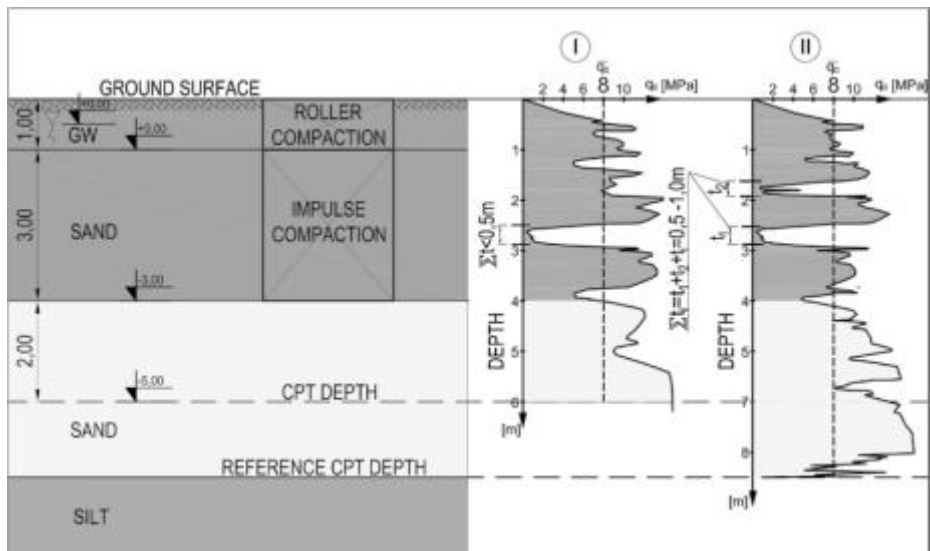
Figure 5. Impulse Compaction acceptance criteria.

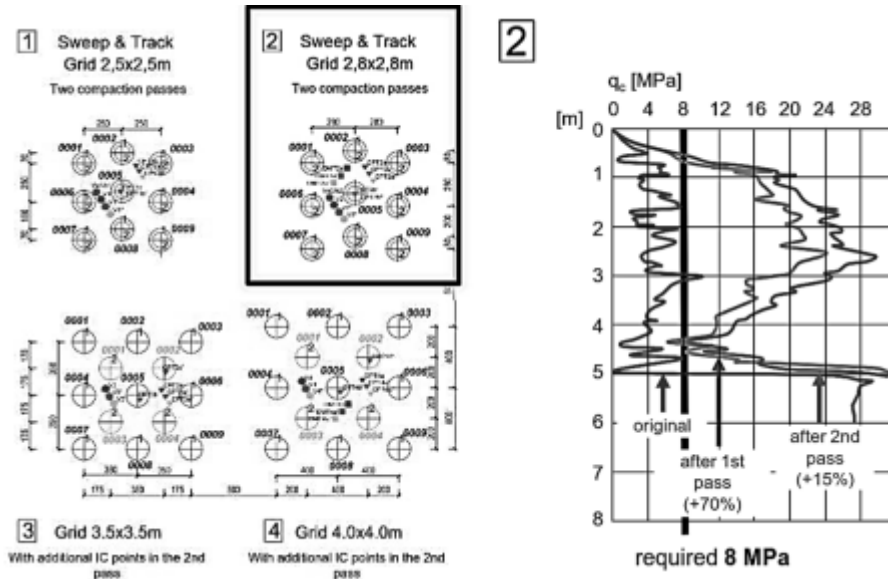
Figure 6. Results of CPT tests after S&T method.

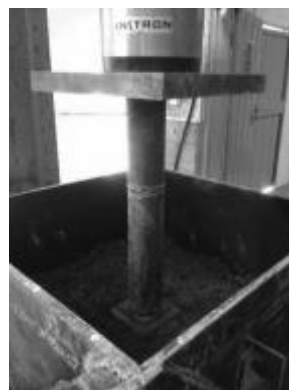
Figure 1. Schematic drawing of the test box and loading configuration

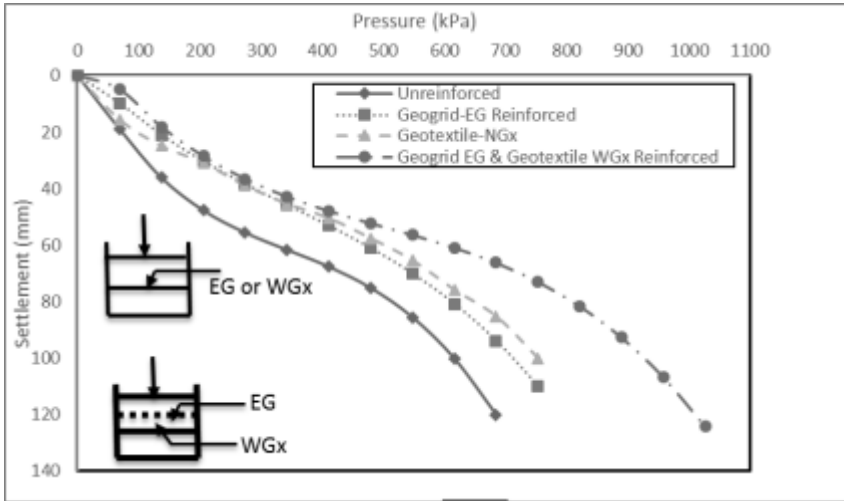
Figure 3. Pressure against settlement of the reinforced and unreinforced composite system (Kiptoo et al., 2017)

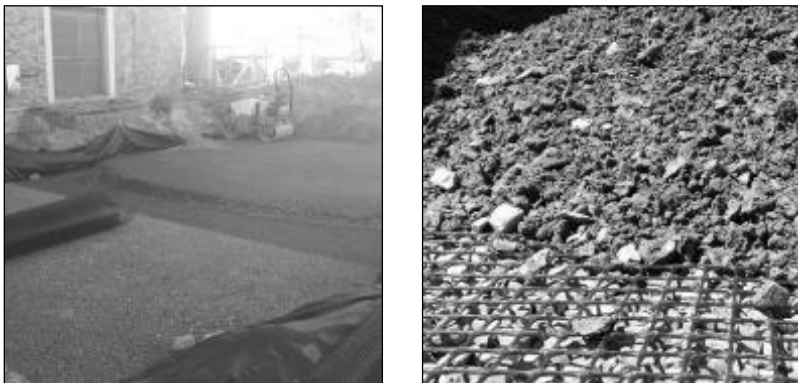
Figure 6. Construction of the geosynthetic reinforced soil raft foundation

Plate load tests were undertaken on the in situ subgrade using a 600mm plate diameter, in the pioneering layer as well as on the installed geosynthetic layers. The axial loads and the corresponding displacement were recorded at predetermined load increments and the resulting data was then used to generate the applied load vs deflection and subgrade modulus reaction curves (figure 7).

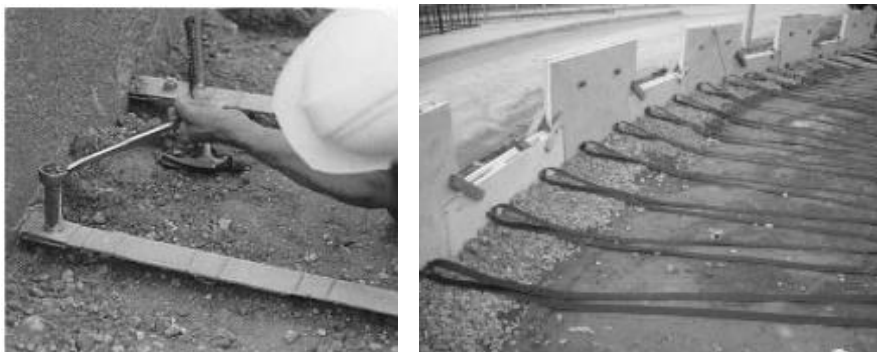
Figure 1. Different connection details and types of reinforcements used.

MSE technology has however branched off into two primary paths: proprietary structures built with metallic (inextensible) reinforcements and proprietary structures built with geosynthetic (extensible) reinforcements, each having a unique combination of precast panels, connection details and reinforcements (see Figure 1).

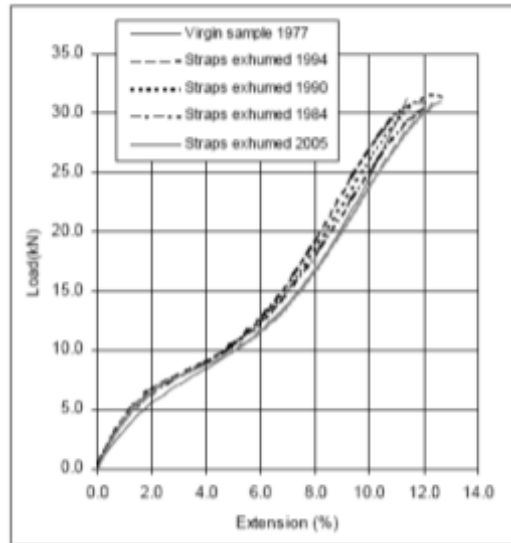
Figure 2. Stress – Strain curves of exhumed samples (Balderson, 2005).

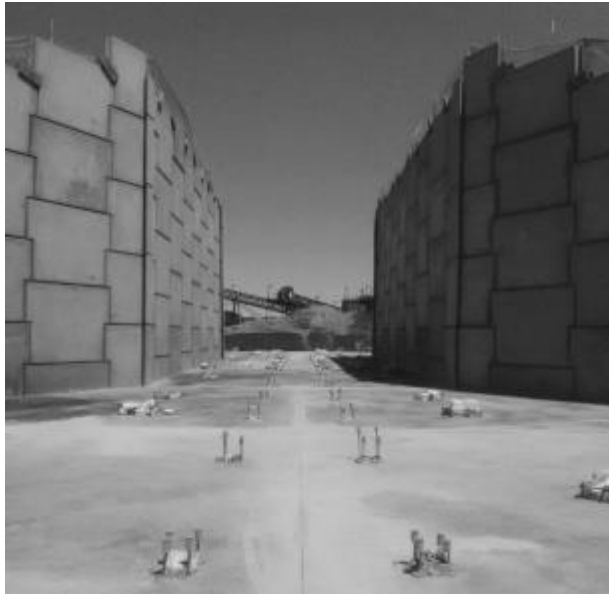
Figure 3. Two of the Four Completed Walls

A total of four retaining walls, 7.5m in height, were required by Black Rock Mine to accommodate tipper trucks dumping material onto conveyor belts for further transportation. Apart from the time and cost constraints, very high loadings and weak founding material had to be overcome in the proposal. The retaining walls were designed not only to retain the fill, which is characterized by a very high density (26 kN/m^3), but also a more stringent requirement was the girder and subsequent bridge bearing on the walls. This generated significant loads and shear forces, thus effectively demanding performance as a true bridge abutment. Figure 3 below shows two of the four walls, just after completion, that supported the bridge deck spanning between them.

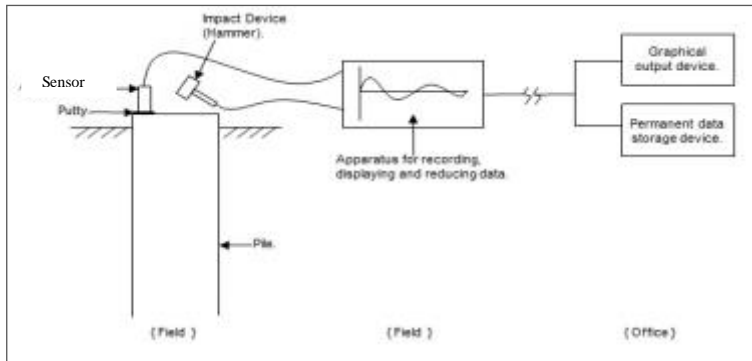
Figure 2. Schematic diagram of the flow of work from the beginning of the pile integrity test to the end stage where the data is analysed in the office (ASTM D5882, 2007).

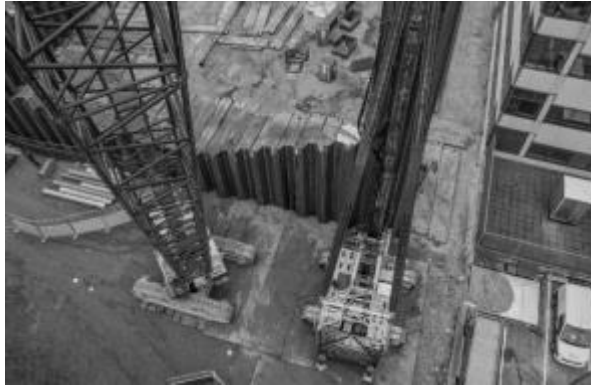
Figure 3. Plan View – Construction Site close proximity to neighbouring buildings

Amsterdam is a highly urbanised area with limited construction space, with existing buildings and roads situated along the edges of the construction site. The foundations of the adjacent buildings and roads were to be protected from collapsing due to excavation works and at the same time providing a dry working site. Since this was an inner city project, noise levels during construction had to be controlled.

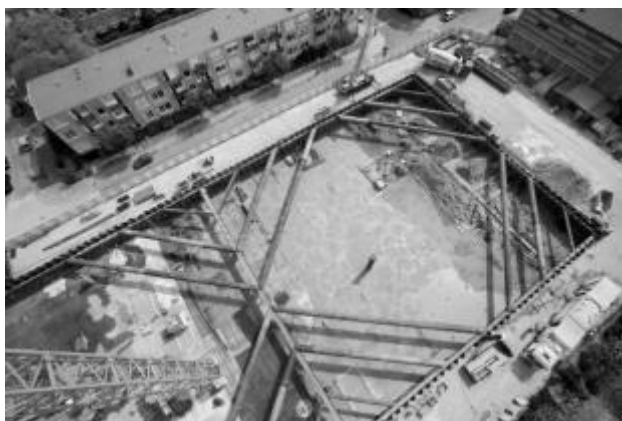
Figure 4. Plan View – Strutting system – During construction

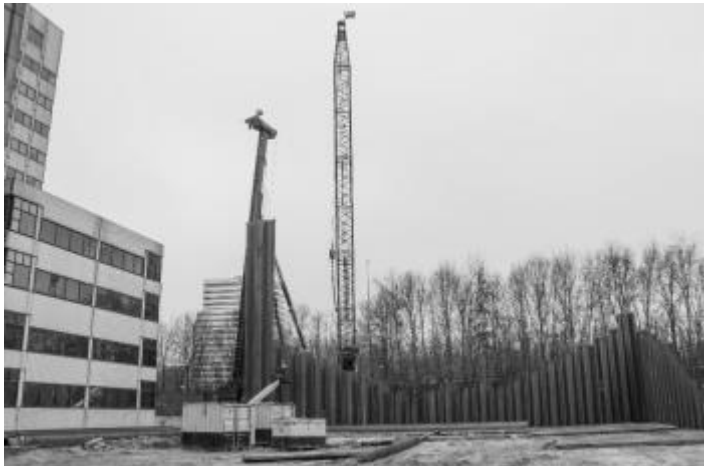
Figure 6. Phase 1 – Installation of Sheet Piles

Phase 1: Installation of sheet piles

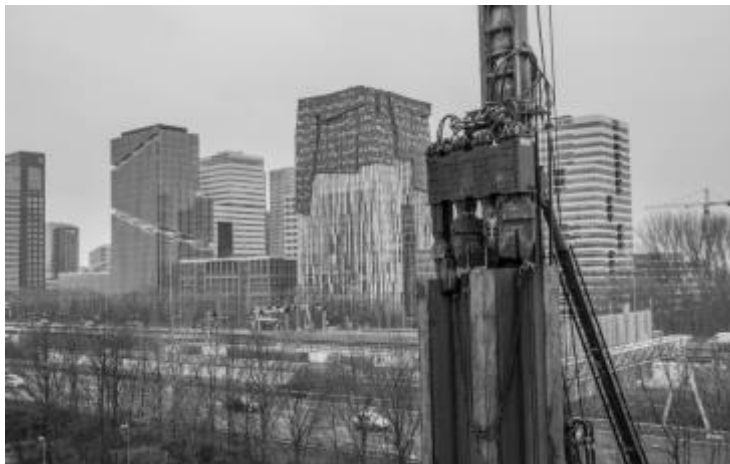
Figure 7. Phase 1 – Installation of Sheet Piles

Before any excavation works within the site boundaries can begin, the first phase was to install the sheet piles to the required depths all around the site boundary (Figure 7 & 8).

To avoid over-stressing the sheet pile walls (Basement walls), excavation was done in stages. Only excavate a few meters below ground at a time to provide enough working space for the installation of the waler beams and struts – first level (see Figure 7).

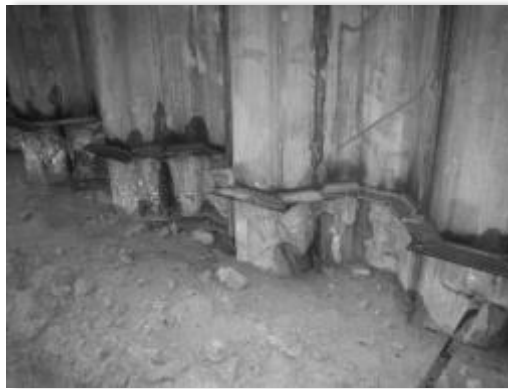
Figure 11. Welded interlocks inside basement to ensure water tightness.

Basement parking's are required to be water tight, during construction and service life. The sheet pile interlocks could either be welded or interlock sealant used.

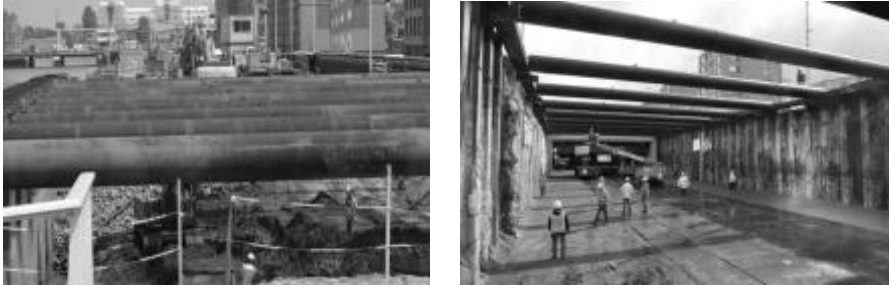
Figure 12. Tunnel construction in Neherkade, Den Haag, Netherlands

Sheetpile walls were a temporary support structure, which were later removed after construction was completed.

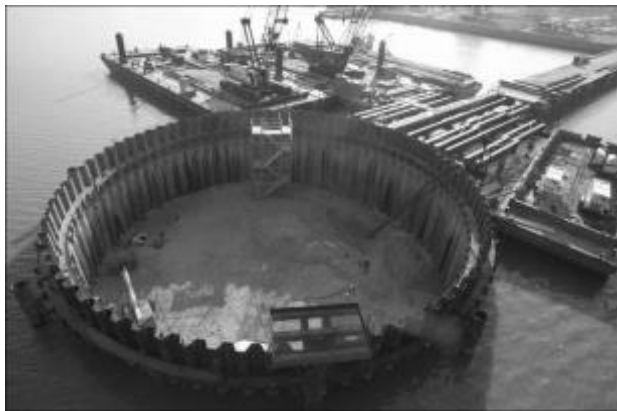
Figure 13. Cellular Cofferdam Breakwater project, Tuban. Indonesia (2005 – 2006)

Cofferdams are temporary enclosure structures built within, or in pairs across, a body of water and soil. By pumping the water out the enclosed area a dry work environment is created so that the actual building activities can proceed. Enclosed cofferdams are commonly used for construction and repair of oil platforms, bridge piers and other support structures built within or over water. These cofferdams are usually welded steel structures, with components consisting of sheet piles, walings, and cross braces. Such structures are typically dismantled after the work is completed.

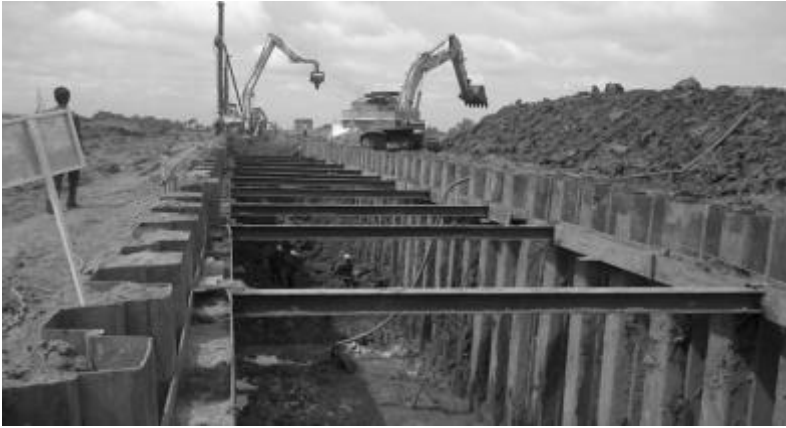
Figure 14. Trench protection: With heavy construction plants operating next to the trench, the excavation had to be protected from collapse. Once the underground pipe was laid the sheet piles are then removed and used on another construction site.

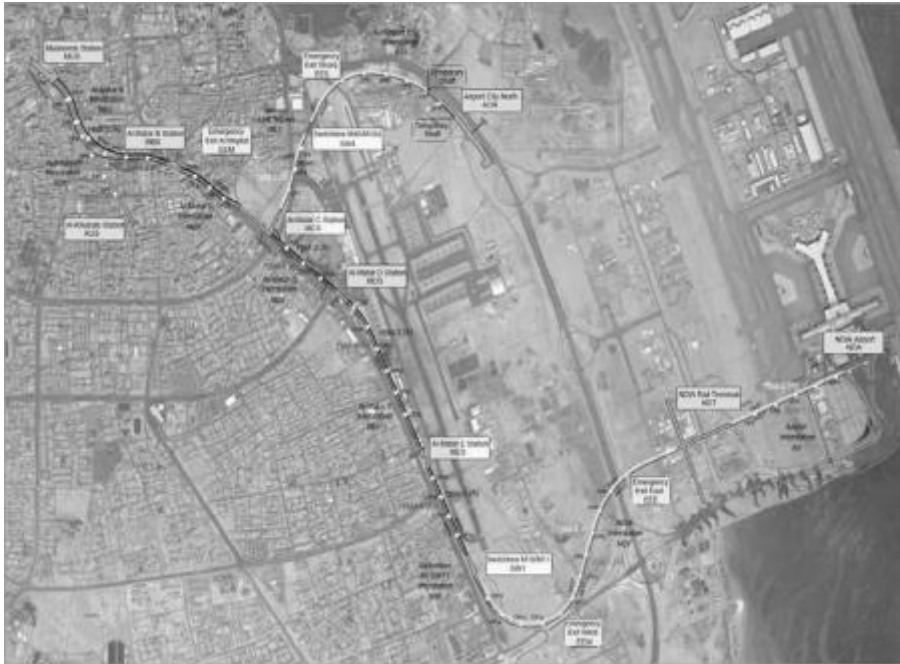
Figure 1. Schematic of the Redline Tunnel South route

Aurecon is currently appointed as Design Verification Engineer for the Doha Redline project which involves the design and construction of 15 km of twin bored tunnel, five underground cut and cover stations, four switchboxes, three emergency escape shafts and numerous cross passages between the tunnels (Figure 1). The Doha Metro Redline South (RLS) Underground Rail is expected to be a dual-tube underground line between Doha and Msheireb in Qatar. The geology of the region is underlain by near surface Aeolian sands and silts (Holocene and Pleistocene) which is underlain mainly by uniform horizontal to sub-horizontal dipping limestone beds. The area comprises upper Dammam which is the Simisima Limestone
